# Failure Investigation of Connecting Rod on Four-Stroke Motorcycle

**Abstract** - The purpose of this research is to examine the mechanism of connecting rod failure on a 110 cc 4-stroke motorcycle that exhibits plastic deformation at the connecting rod neck. Visual inspection, chemical composition testing, metallographic testing, hardness testing, and numerical simulation are the analytical techniques employed. The connecting rod material is classified as SAE-AISI 4140 steel based on the findings of the chemical composition test. The results of the metallographic tests revealed the presence of a martensite phase in the microstructure. The connecting rod material's average hardness value, as determined by the Vickers technique of hardness testing, is 500 HV. Similarity between the buckling failure mode, which happens when the load absorbed by the connecting rod exceeds the normal load and occurs in the vicinity of the maximum stress point, may be shown from stress analysis (von Mises) and buckling mode analysis (eigenvalue buckling). The history of riding motorcycles that have been altered by adding compression to get the required speed without taking the strength of the connectin

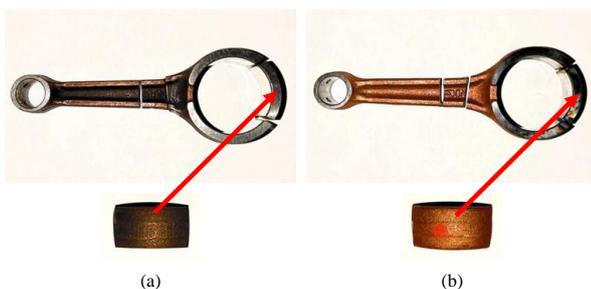
Figure 2: Test specimen for the chemical composition of connecting rods (a) Failed (b) New

The results of the chemical composition test are displayed in Table 1. Based on their chemical composition, it is known that the two connecting rods are classified as SAE-AISI 4140 steel, which is the same as 41CrMo4 in the German designation (DIN) [8].

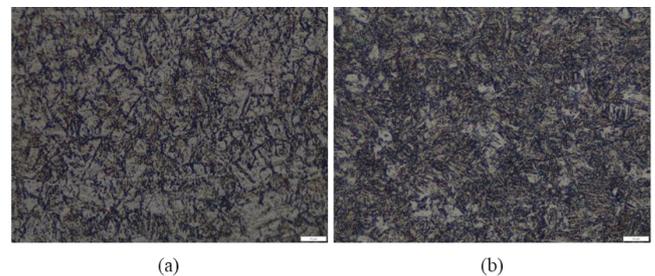
According to the metallographic test results displayed in Figure 6, the martensite phase is present in both connecting rods. These findings suggest that the connecting rod that failed did not have any mistakes or manufacturing flaws. The martensite phase results are also consistent with the heat treatment used in the production of connecting rods, which includes tempering to raise the toughness value and quenching to achieve high strength. This microstructure can be demonstrated by comparing it to the microstructure of AISI 4140 steel, which is depicted in Figure 7 and likewise underwent heat treatment in the form of quenching and tempering with the same phase form, namely martensite.

Figure 6: Results of the metallographic test a connecting rod using a 1000x magnification (a) Failed (b) New

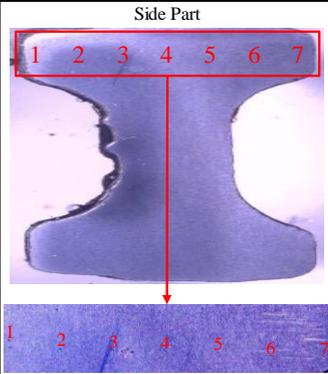
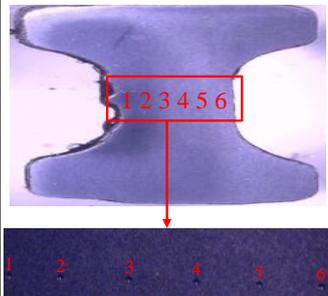
Table 2 displays the findings of the Vickers method hardness testing that was conducted at 13 points. With an average hardness value of 500 HV, it is known that there are no appreciable differences between the two connecting rods' hardness value distributions. These findings suggest that wear factors on failing connecting rods do not alter the hardness values [10].

1	558	583
	2	515	565
	3	478	523
	4	474	521
	5	496	532
	6	506	537
	7	517	565
Middle Part

1	530	558
	2	506	551
	3	480	521
	4	474	515
	5	488	551
	6	510	563

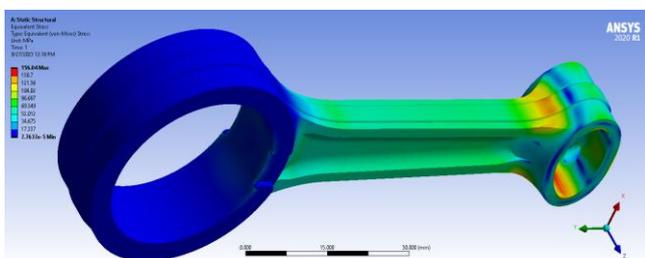
The inner circle of the big end is determined as a fixed support [11] as illustrated in Figure 8. The results of stress analysis (von Mises) with a normal load of 4,165 N applied to the inner circle of the small end in the direction of the connecting rod neck axis show that the maximum stress point occurs in the area near the small end of the connecting rod with a maximum stress value of 156 MPa under the connecting rod's yield strength of 415 MPa, indicating that the connecting rod should be safe for use under normal loads.

Figure 8: Von Mises connecting rod stress analysis results

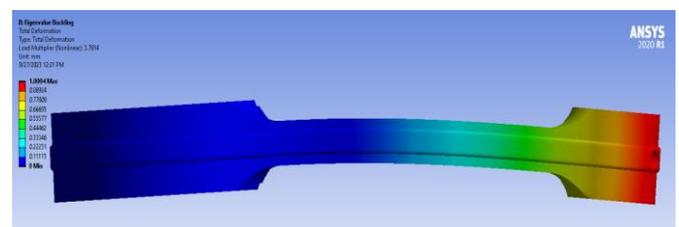
Additionally, it was discovered through buckling mode analysis (eigenvalue buckling) that the first buckling mode—with a maximum buckling load value of 15,743 N, or 3.78 times greater than the normal load—was the one that actually

occurred. As seen in Figure 9, the first bending mode that arises from the bending mode analysis results resembles real connecting rod failure. The point of maximum bending stress, which is situated in the region of the connecting rod neck with the smallest cross-sectional area and occurs close to the point of maximum stress [6], provides evidence of the similarity of this bending mode.

Figure 9: (a) Analysis of buckling modes (eigenvalue buckling) (b) Connecting rod failure that occurred

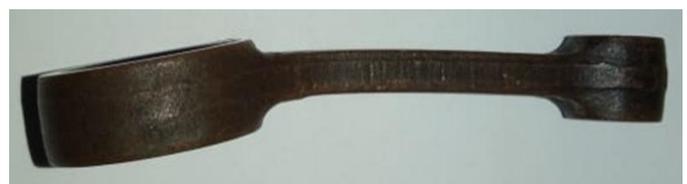
(b)

According to the test results, the connecting rod material's chemical makeup is low alloy steel, which falls under the SAE-AISI 4140 steel category. An average hardness value of 500 HV is used to characterize the microstructure formed by the connecting rod material, which is martensite. Since the connecting rod's material satisfies SAE-AISI 4140 steel standards, it cannot be the reason for the connecting rod's failure. Excessive load applied to the connecting rod causes buckling failure at the connecting rod neck, which is the mechanism of failure. The findings of the buckling mode (eigenvalue buckling) and stress analysis (von Mises) demonstrate that the maximum bending stress point and maximum stress point are comparable to the real failure circumstances that arise in the connecting rod. The primary reason for failure is that the connecting rod experiences an excessive load, which happens when the motorcycle is altered by adding more compression to reach the intended speed without taking the connecting rod's strength into account.
