Failure Analysis on Hammer Crusher in Clinker Cooler

Abstract - Hammer crusher is one of the main components in the clinker cooler. A hammer crusher is a tool for crushing clinker that has cooled to reduce the size of the slag. The Hammer crusher wears out which causes its service life not to match its ideal use. The purpose of this study is to determine the cause of the failure of the hammer crusher, to know the mechanism of the failure of the hammer crusher, and to find the solution for the failure of the hammer crusher. The methodology used to solve the problem is by conducting tests where the tests carried out to analyze the hammer crusher material is composition testing carried out with the OES tool, hardness testing using the Vickers method, impact testing using the Charpy method, and metallography observed under an optical microscope. Based on testing the material composition of the hammer crusher is not up to standard. Then from the hardness test, the average value is 569.8 HVN on the hammer worn part and 481.2 HVN on the part far from worn. From the impact test, the average impact energy value in the wear section is 1.917 Joules with an average impact strength of 0.023 Jo

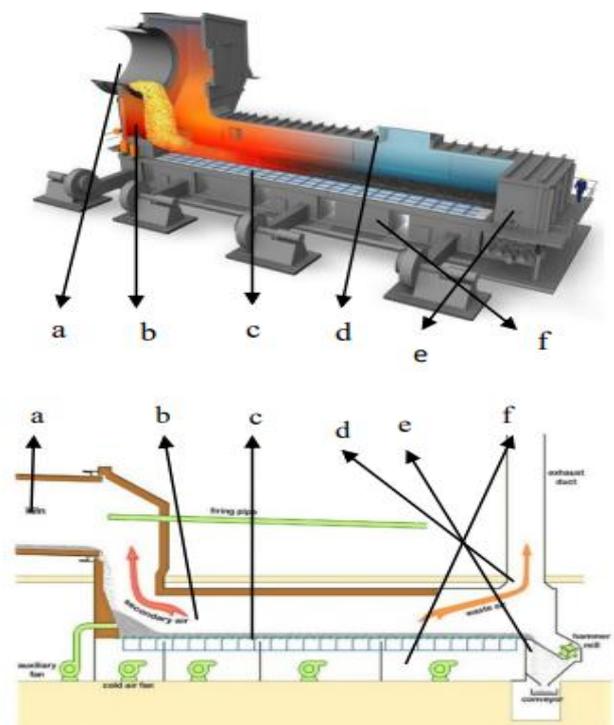
In the cement manufacturing process, after the burning process is carried out, the next step is the material cooling process which is carried out in the clinker cooler. Figure 1 shows the main components of the clinker cooler. The cooling process starts when (b) the clinker comes out of (a) the rotary kiln and is continued by (c) the crossbar to (e) the hammer crusher who reduces the initial size of the clinker. During the journey to the hammer crusher, the clinker is cooled by the (f) fan under the crossbar and the hot air in the clinker cooler exits through the (d) exhaust duct, then the clinker is crushed by the hammer crusher into a larger size. small [2].

Figure 1: Clinker cooler components [2]

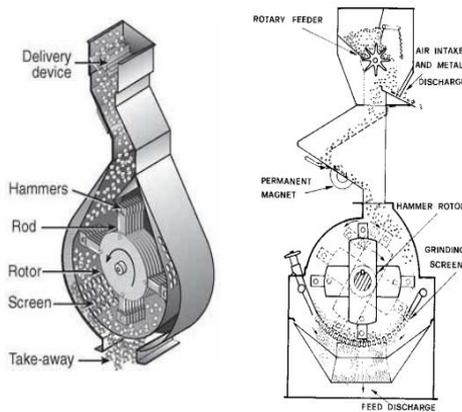
A hammer crusher is a grinding tool that has a rotating rotor and a hammer-shaped breaker where the hammers are hung on a rotor that can rotate quickly. Figure 2 shows the hammer crusher components, including feeders that function as flow regulators and separators of materials and raw material receivers. Hammer is a component that functions to break down and reduce the size of the material, and a screen (sieve) is a component in stone crushing equipment that functions to filter, form gradations, and indirectly control the distribution of material to the crusher unit [3].

Figure 2: Hammer crusher components [3]

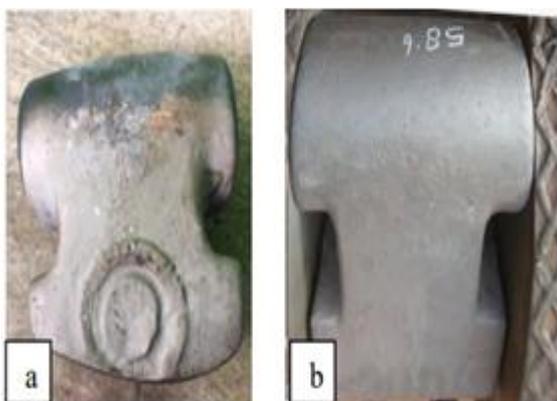
The hammer crusher material used is high chromium white cast iron steel which has a chemical composition as shown in Table 2. The hammer crusher in the clinker cooler experiences wears as shown in Figure 3. Figure 4 and Table 3 are the design and specifications of the hammer crusher material.

Figure 3: (a) Hammer crusher that is worn out, (b) hammer crusher that is still intact [16]

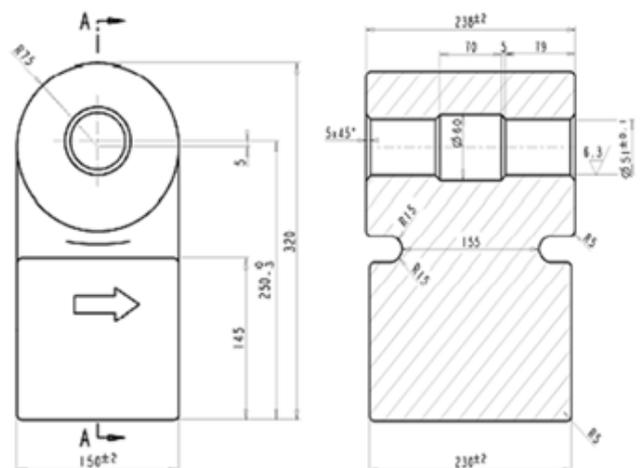
Figure 4: Hammer crusher design [17]

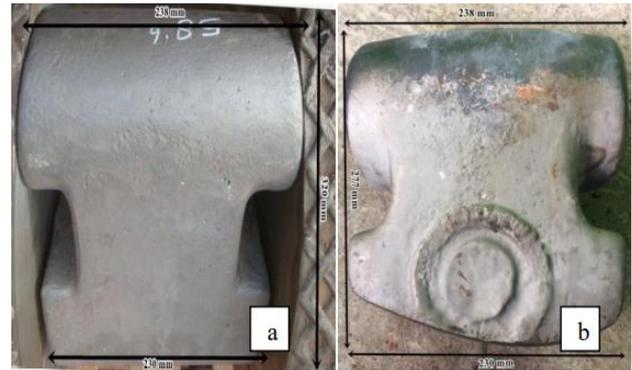
Figure 6: Hammer crusher (a) before wear (b) after wear [16]

After calculating the volume of wear, the material experienced a material loss of $3,616,764.71 \text{ mm}^3$ or $3,616,765 \text{ cm}^3$.

Based on the results of macro visual observations on the hammer crusher components that are experiencing wear and tear in Figure 6, it can be seen that the hammer crusher material wears out and there is a reduction in the dimensions of the hammer crusher which initially had a length of 320 mm, to 277 mm.

1. The factors that cause failure of the hammer crusher in the clinker cooler are the inappropriate material composition and the low toughness value compared to the standard.
2. The hammer crusher failure mechanism in the clinker cooler occurs due to wear caused by differences in hardness values and changes in the mechanical properties of the material.
3. To overcome the failure is to replace the material according to the standard composition of ASTM A532.

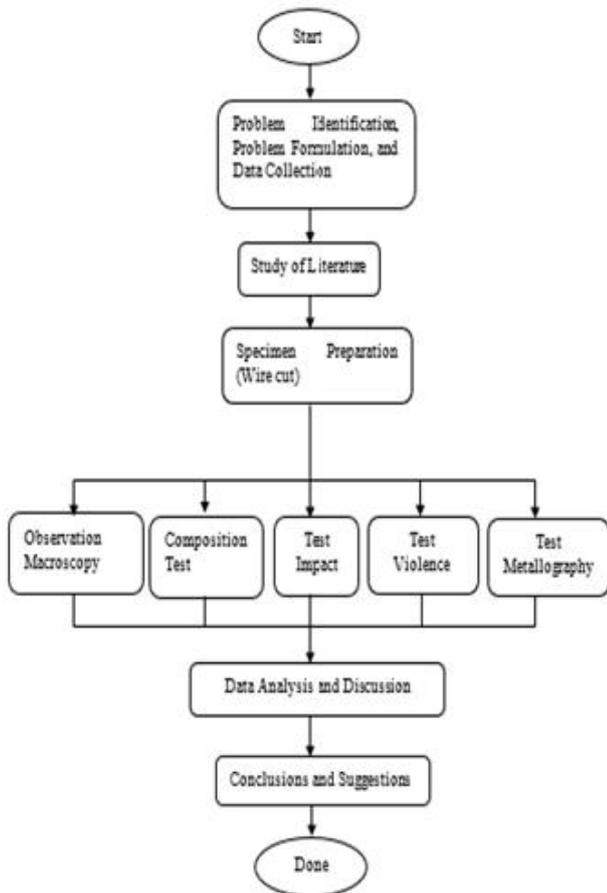
The problem-solving process carried out will be explained using a flow chart to make it easier to understand. The flow chart can be seen in Figure 5.

Figure 5: Flow chart

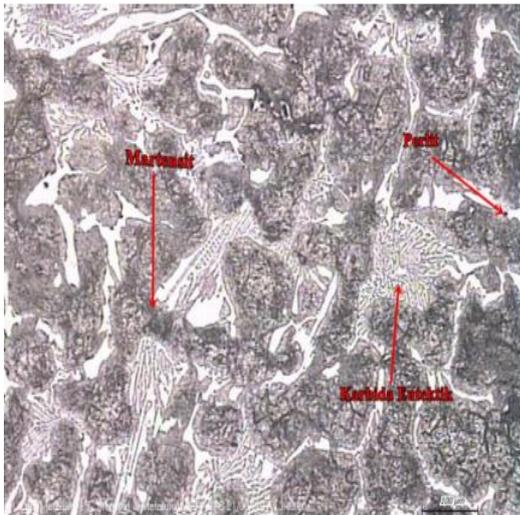
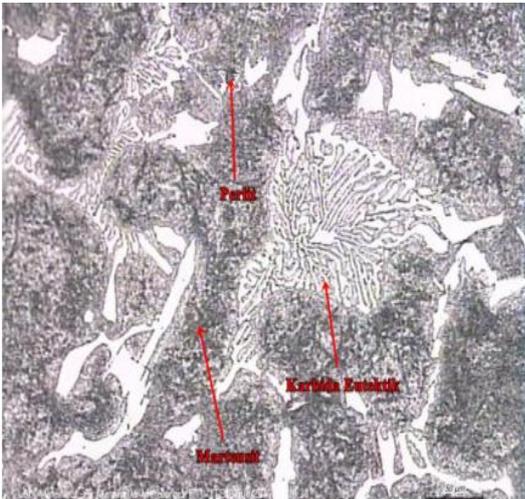
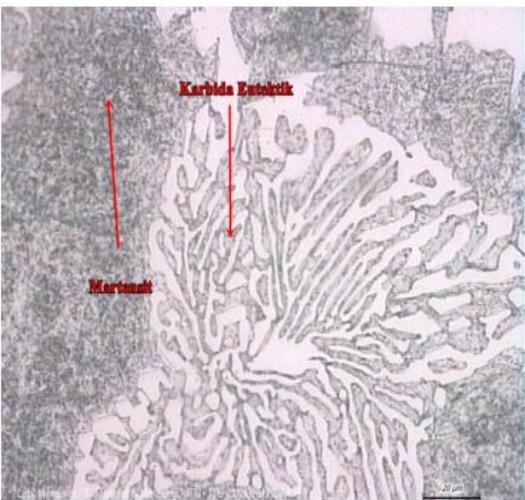
Figure 7: Microstructure of the material away from worn hammer crusher at 100x magnification [16]

Figure 8: Microstructure of the material away from worn hammer crusher 200x magnification [16]

Figure 9: Microstructure of material away from wear hammer crusher 500x magnification [16]

Based on the observation of the hammer crusher microstructure above, obtained pearlite, martensite, and chromium carbide where pearlite is shown in gray with white spots, chromium carbide is shown in large white color, and martensite is shown in dark color. Pearlite is the result of a lamellar mixture of ferrite and cementite which is formed from

the decomposition of austenite through a eutectoid reaction in equilibrium. The pearlite matrix has low abrasive resistance but has good toughness so that the role of pearlite in cast iron is less needed [19]. Based on observations, the hammer crusher material located in an area far from hammer wear has a finer chromium carbide shape, compared to the hammer wear area, which affects the hardness properties in that area. In high chromium alloy white cast iron, the fine carbide structure in the matrix will provide an excellent combination of hardness and toughness when compared to the coarse carbide structure. The combination of hardness and toughness is the main factor of high chromium alloy white cast iron material [8].

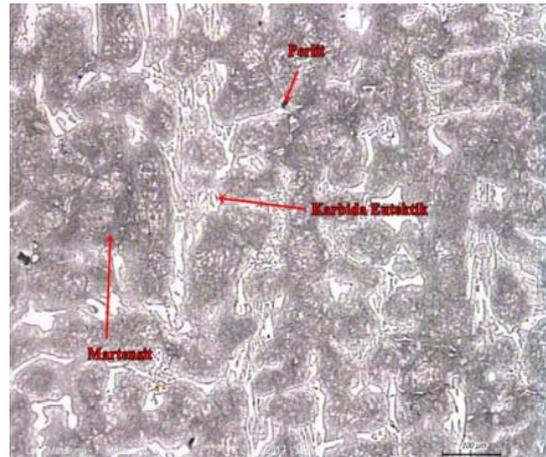
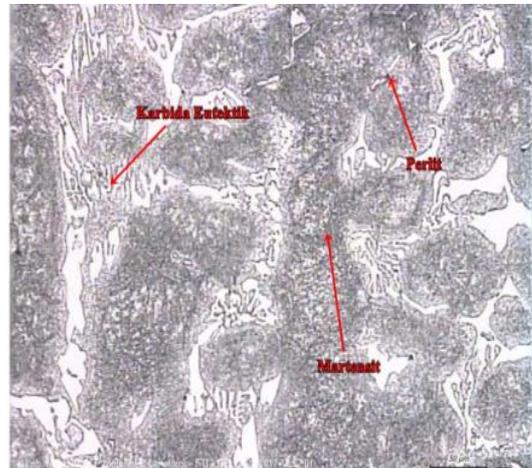
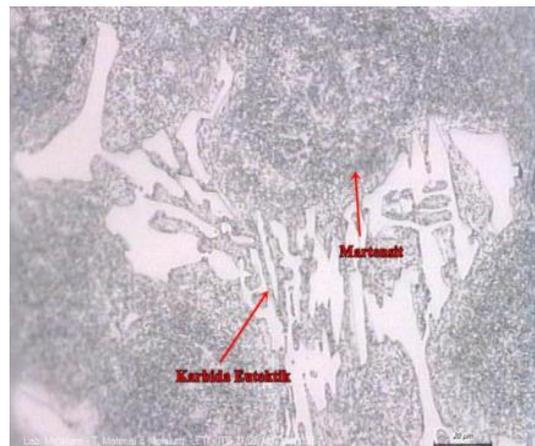
Figure 10: Microstructure of hammer crusher wear material at 100x magnification [16]

Figure 11: Microstructure of hammer crusher wear material 200x magnification [16]

Figure 12: Microstructure of hammer crusher wear material 500x magnification [16]

The failure of the hammer crusher is due to wear and tear that occurs due to a mismatch in the main material elements, one of which is the lack of carbon content and changes in the mechanical properties of the material, where the hardness value of the hammer crusher material increases but decreases the ductility and the impact energy value of the material is far below the standard. This can be caused by operational processes that cause continuous friction so that the toughness of the material becomes lower and makes the hardness of the material increase due to strain hardening but makes the material more brittle.
