# Behavior Investigation of Arch Beams Using Different Types of Strengthening Methods

<sup>1</sup>Saadi M. Al-Dabbagh, <sup>2</sup>Dr. Suhaib Y.K. Al-Darzi

<sup>1</sup>M.Sc. Student, University of Mosul, College of Engineering, Civil Engineering Department, Mosul, Iraq

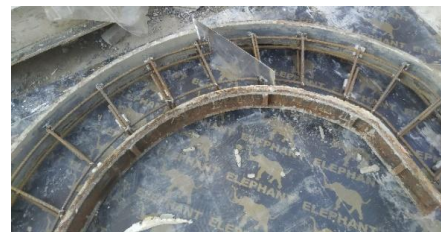
Figure 3: Preparing the Crack specimens (Ic1 and Ic2). (The drawing's dimensions are in meters)

The specimens with cracks (Ic1 and Ic2) were created by placing a (1.0 mm) thickness plate along the beam before concrete casting. The plate was removed after six hours of concrete casting. The crack's locations and shapes are shown in Figure (3). The same curing procedure was used, and then at (28) days, an epoxy resin was used to inject the cracks. The specimen (Hc2, Ic1, and Ic2) was then wrapped with a (CFRP) sheet, as shown in Figure (4).

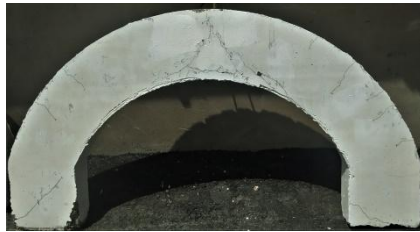
(a) Beam (S)

Figure 6: The shape and distribution of cracks for the tested beams

By testing the standard specimen (S), it was noticed that the first crack appeared at a load of ( $P_{cr}=41\text{kN}$ ) with a crack deflection at midspan ( $\delta_{cr}=1.2\text{mm}$ ). That diagonal cracks start from the bottom at the mid-span and extend upward to the

applied load point. Then horizontal cracks were initiated in the bottom middle region. Diagonal cracks appeared at the top of the beam at a quarter of the beam span from both sides. The failure load was equal to ( $P_f=250\text{kN}$ ) with a failure deflection at midspan ( $\delta_f=7.15\text{mm}$ ), and the concrete was crushed at a crushing (fracture) load of ( $P_{fract}=320\text{kN}$ ) with a fracture deflection at midspan ( $\delta_{fract}=10.6\text{mm}$ ).
